PLAN 1B & 1C

(From TpSI H20 II - February 1965) E N D

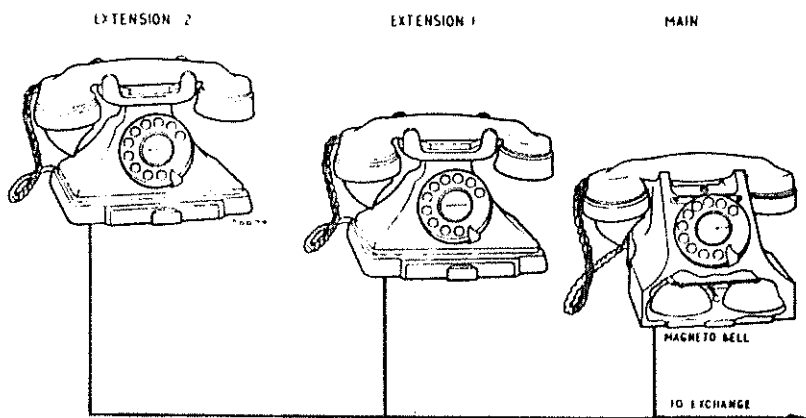
PLAN 1B (Obsolescent)

Plan 1B This was similar to the present plan 1A but the extension telephones had no bells or press buttons. It was provided only in situations where the main bell could be heard.

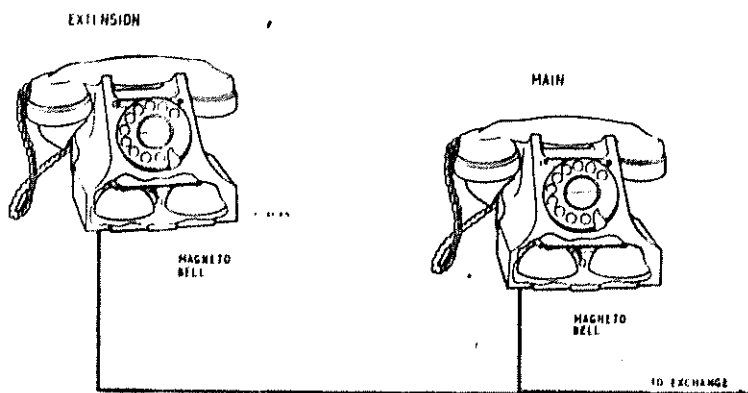
PLAN 1C (Obsolescent)

Plan 1C This was similar to the present plan 1A but the extension telephones had no press button to disconnect the bell.
