The Ericsson Bulletin

No. 15

JULY, 1939

P.A.B.X. Equipment Waverley Station, Edinburgh

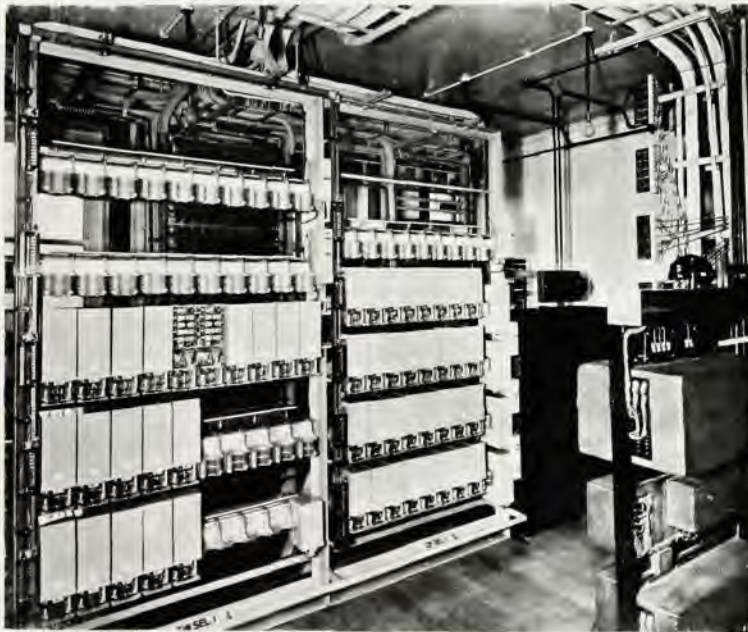
Automatic Exchange Equipment, Waverley Station, Edinburgh

The group selector rack has capacity for 6 groups of switches, each group consisting of nine group selectors and one assigner. As in the case of line finders, only 8 group selectors per group are fitted, the ninth position being for ultimate extension. Wiring for five groups is provided initially, with equipment for four groups. Each group occupies one shelf on the rack. The general arrangement of the group selector rack, and also of the final selector rack, is shown in the illustration of the equipment.

The final selectors are also arranged in groups, each catering for 100 subscribers lines. A full group would consist of 15 switches, but only 10 switches per group are required to cover present traffic figures. The final selector rack is wired for the full capacity of three such groups, but only two are equipped. The height of this rack, as of all the auto racks, is 8'-6½". Suitable alarm arrangements are provided throughout, and are extended to the manual board.
