# ROYAL VISIT TO SOUTH AFRICA

## INTER-TRAIN V.H.F.

### COMMUNICATION EQUIPMENT

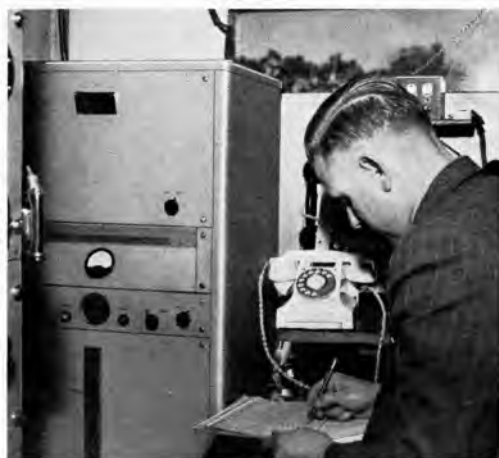
Fig. 1.—Operating position, Royal Train.

After due consideration of the many factors involved, a slightly modified version of the G.E.C. 100-watt F.M. transmitter with built-in receiver was installed in each train. This transmitter and its associated receiver were fully described in *Telecommunications*, Vol. I, No. 2, 1946. Fig. 1 shows how it was installed in the somewhat confined space available. The smallness of this space and the need for installation close to the coach wall necessitated a slight modification in design to allow the individual units to be withdrawn from the front for maintenance purposes. Slight extension of the inter-unit connexions and the provision of runners for the individual chassis enabled this feature to be incorporated.

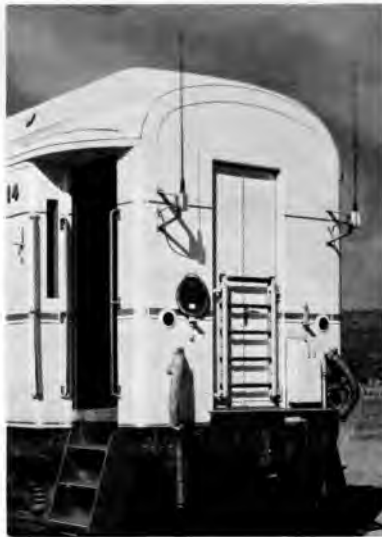
**Fig. 2.—Rear-mounted aerials.**

Three interchangeable aerials were provided, primarily to guard against possible interruption of communication due to accidental damage. All three were of the flexible vertical-rod type, one being mounted on the roof of the coach with the remaining two at the rear (Fig. 2). The low-impedance output from the transmitter was fed into a special aerial coupling unit which had three output sockets, one of 40 ohms impedance and the other two of 72 ohms

each. The roof aerial, a quarter-wavelength radiator, was fed from the 40-ohm output, while the two rear aerials were fed in parallel from the 72-ohm outputs. The rear aerials were end-fed half-wavelength elements but owing to their location at the rear of the coach and the consequent screening effect, the effective length was considerably reduced. The operator utilised the aerial coupling unit to select the best aerial combination for any given conditions.
